THE **BOEING** COMPANY

DOCUMENT NO. D2-100645-1

TITLE: THE EVALUATION OF A COMPOSITE TEFLON/ALUMINUM
EXPULSION BLADDER FOR USE IN NITROGEN TETROXIDE

MODEL LUNAR ORBITER CONTRACT NO. NAS 1-3800

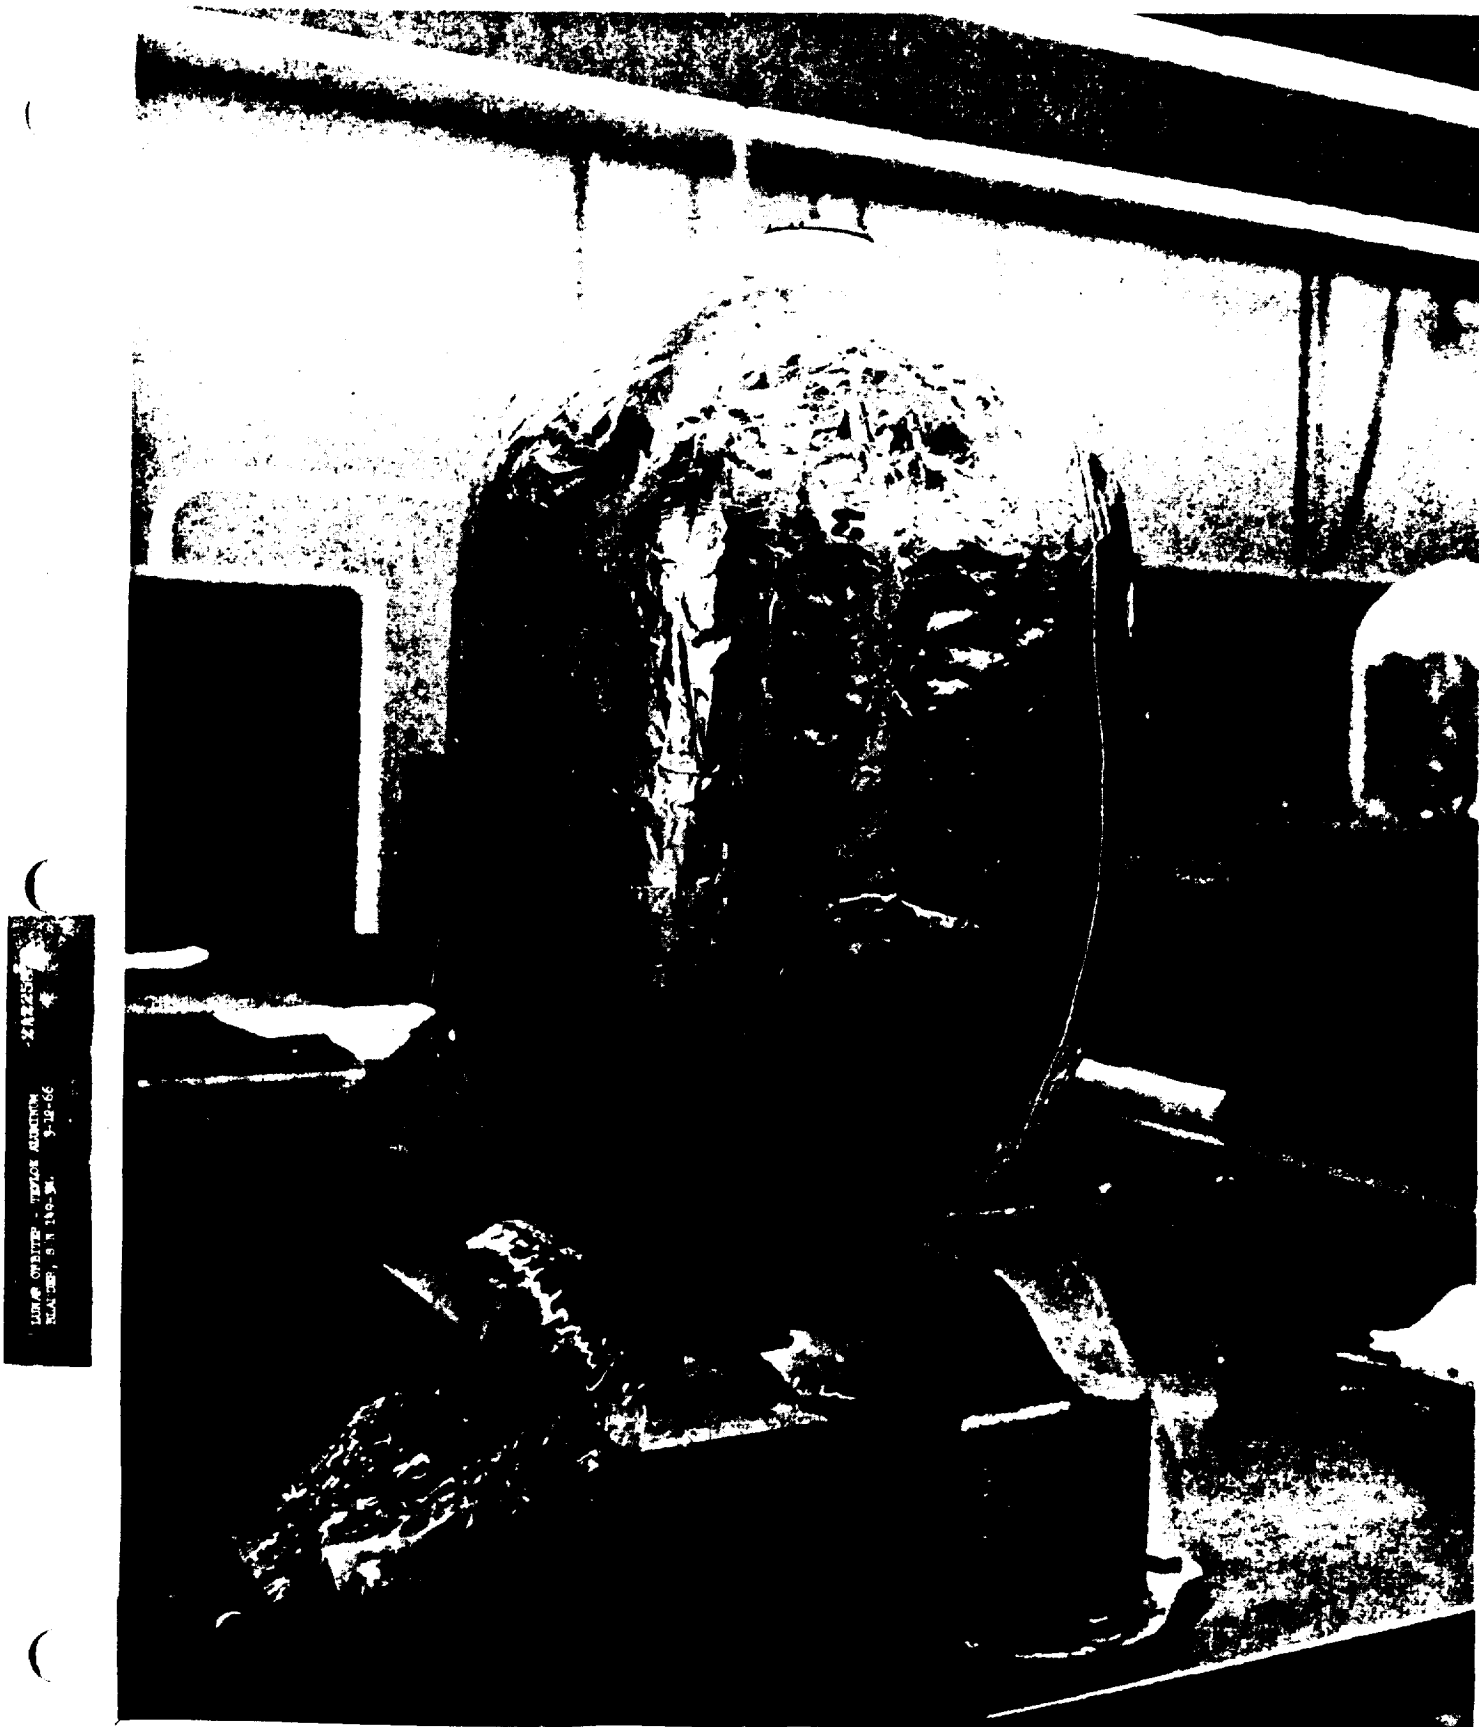
Figure 22

BLADDER S N 149-3M. POST TEST

Both tank assemblies were flushed with Freon/methanol and returned to the MPC on 11 March. During this phase of the test program, oxidizer had been present in Tanks S/N 4 and S/N 10 for a total of 1630 hours and 1584 hours, respectively. Post-test disassembly revealed that both bladders were generally in excellent condition; some minute cracking of the aluminum was evident as previously discussed in Section 5.0. There was no distinguishable deterioration or corrosion, nor any tearing of teflon or aluminum lamina. Bladder S/N 149-3M exhibited localized delamination between the aluminum and outer FEP laminas in the region of the unit's aft extremity (i.e., flange end). Photographic views of Bladders S/N 152-3M and 149-3M are shown in Figures 21 and 22, respectively.
